GEOLOGIC HAZARDS EVALUATION

CITY OF SANTA BARBARA

October 27, 1978

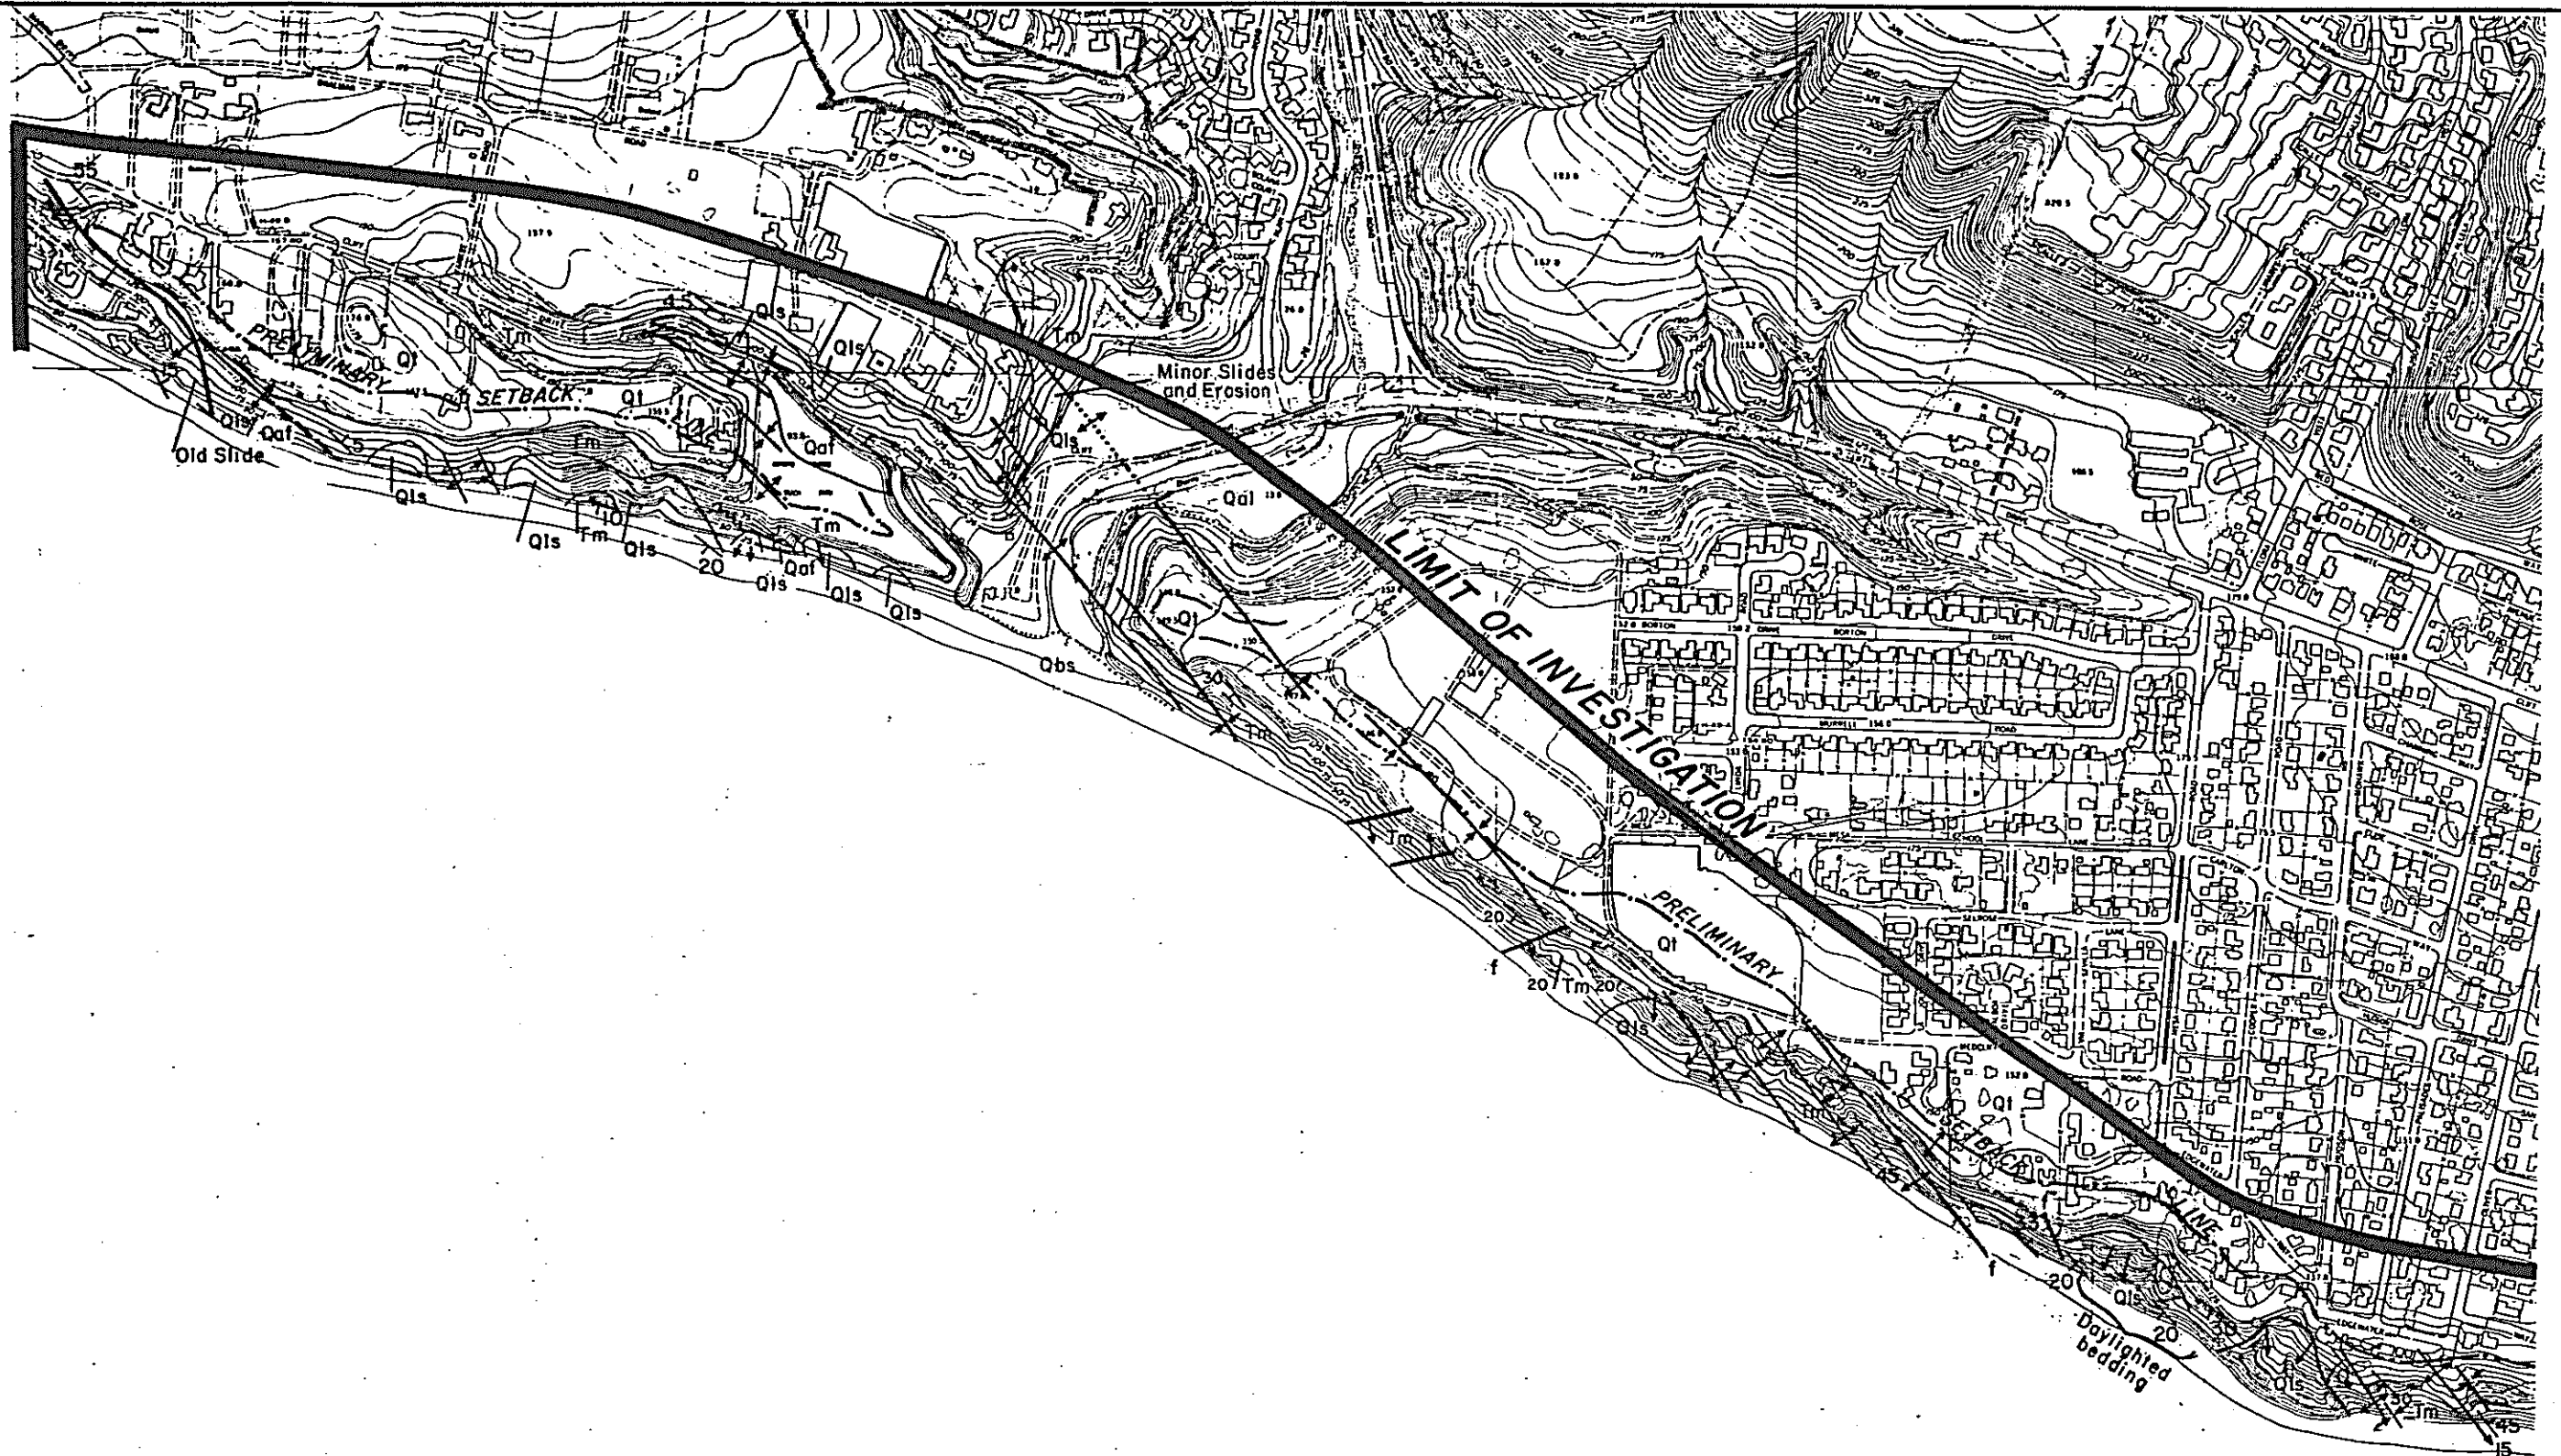
THE CITY OF  
 SANTA BARBARA  
 COASTAL HAZARDS MAP  
 GEOLOGIC STABILITY OF BLUFF

Plate 7 is a detailed geologic map of the seacliff area in the City of Santa Barbara. The stability of the seacliff depends on the geometric relationship between geologic structures (bedding planes, fold axes, and joints) and the bluff face.
